# A Storm Drain Success Story: Two Tunnels and a Landslide

By Randall G. Berry, PE, Director of Engineering Services

*This paper first appeared in the North American Society for Trenchless Technology (NASTT) 2015 No-Dig Show, March 2015.*

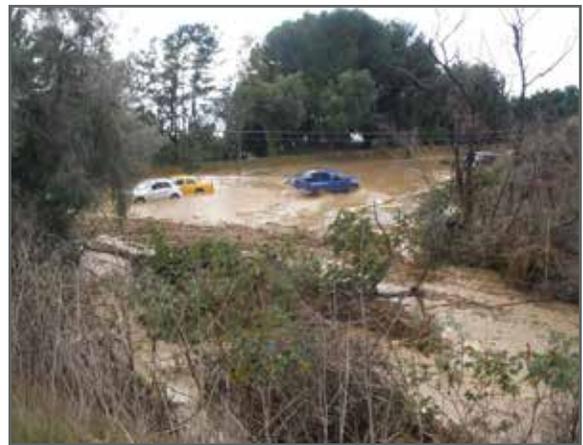
Figure 2. Flooding on 25th Street/Palos Verdes Drive South (PVDS) during a January 19th, 2010 storm.

After years of planning and coordination with the County and City of Los Angeles it became clear to the City of Rancho Palos Verdes staff that if this \$15.1 million San Ramon Canyon Drainage Improvement Project was going to be built, they would have to take the lead themselves. This included obtaining \$9.4 million in funding from an Integrated Regional Water Management Storm Water Flood Management Grant, Proposition 1E, designing and constructing the largest public works project that the city had ever undertaken. The project became all the more urgent after the flooding that was experienced during the winter of 2010, as shown in Figure 2.

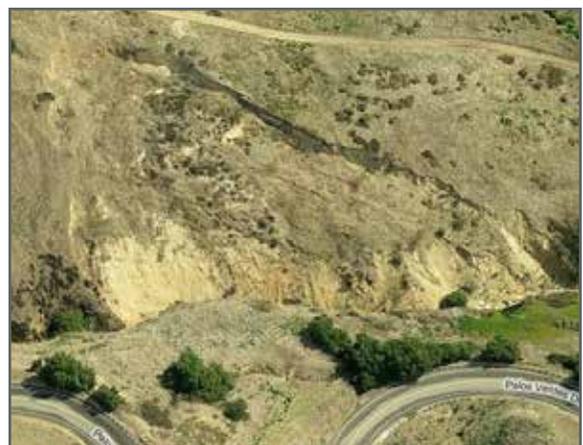
Figure 3. Tarapaca Landslide east of San Ramon Canyon and Palos Verdes Drive East (switchbacks).

The project included significant canyon grading to form a stabilizing buttress fill adjacent to the Tarapaca Landslide (see Figure 3) and 100-year plus storm drainage diversion system (see Figure 4). The project included some unique and innovative elements to protect more than 250 homes that were directly downstream and two of the region's major arterials, namely 25th Street/Palos Verdes Drive South, which was being regularly flooded downstream, and Palos Verdes Drive East (switchbacks) directly to the west, which had slopes that were being undermined at a rate of up to five feet per year.

The Tarapaca Landslide consisted of a 30-foot high near vertical eroded slope (see Figure 14 and previous Figure 3) that continued to slough into the canyon bottom and then be carried downstream during major storm events. The slide area was stabilized by introducing an engineered fill, complete with sub-drain mainline and “fingers” (see Figure 16). The canyon bottom was then lined with a rip rap rock, which included smaller rock fill in the interstices to allow a four wheel drive maintenance vehicle to access the entire length, and the adjacent slopes were landscaped with native plants and irrigated (see Figure 15). The landslide itself (surface and underlying soils) was “off limits” due to private ownership and as such will either require future grading by the landowner or left to simply “heal” through years of corrective erosion and localized settling.

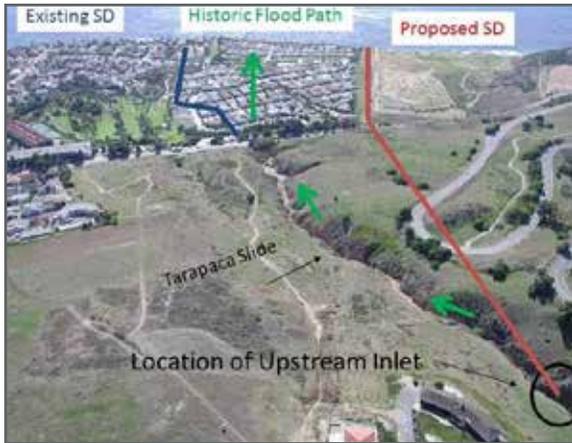
Figure 4. Overview of San Ramon Canyon Storm Drain looking downstream.

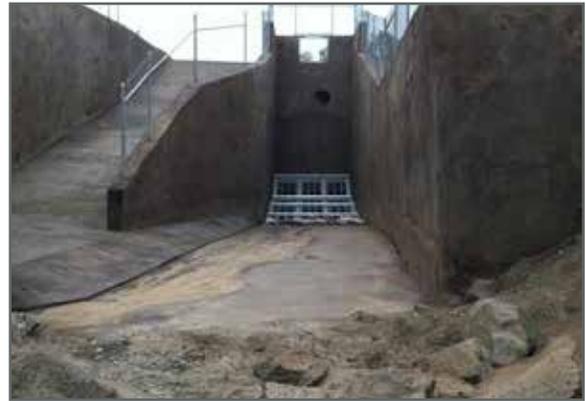
Figure 6. Completed upstream inlet structure.

the same as the natural creek process that has occurred for thousands of years before the surrounding land was developed, allowing the replenishment of sand and cobbles at the beach. This also eliminates a considerable amount of maintenance by not having to remove reoccurring sediment from an upstream inlet structure (see Figure 6).

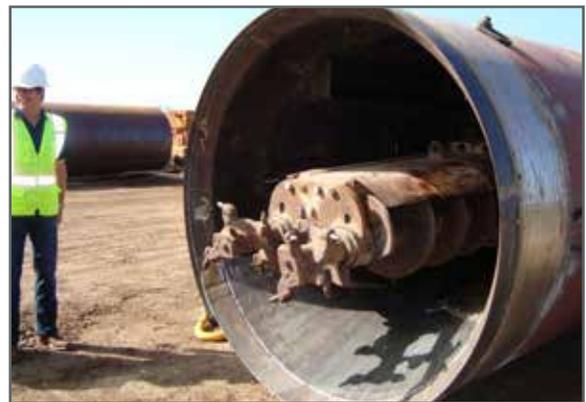
Figure 7. Lower tunnel Rotohead excavator.

The 80-inch diameter steel sleeve tunnel (see Figure 8) was excavated through solid bedrock via a Rotohead excavator (see Figure 7) at a steep slope (38% profile grade) within the 150-foot high coastal bluff along the Pacific Ocean. Once the steel sleeve was jacked into place then the 54-inch diameter steel storm drain pipe could be installed, with the annular space grouted. A top-down tunneling method was required because of environmental concerns (limiting impacts and equipment on the beach) and due to limited access on the beach (the only access point was from White Point-Royal Palms Beach approximately three quarters of a mile to the southeast).

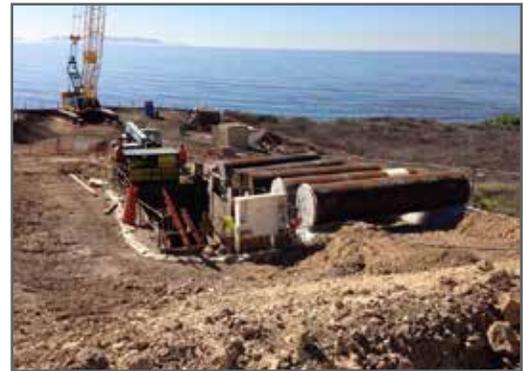
Figure 9. Lower tunnel launch pit 150-feet above the Pacific Ocean (with Catalina Island beyond).

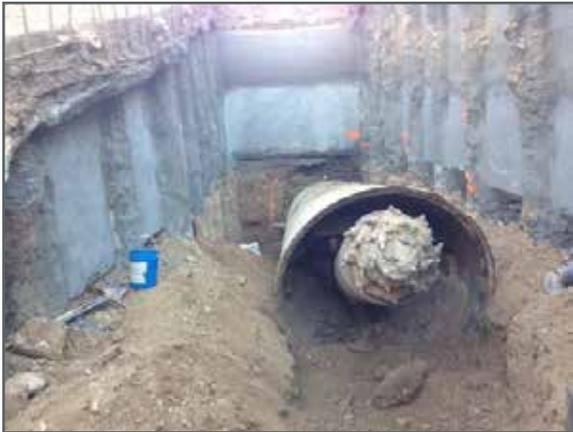
Figure 11. Upper tunnel Rotohead excavator as it emerges into the upstream inlet structure.

The 80-inch diameter rib and lagging tunnel (see Figure 10) was excavated through a dormant landslide via a Rotohead excavator (see Figure 11) at a fairly steep slope (14% profile grade) for a distance of 2,200-feet

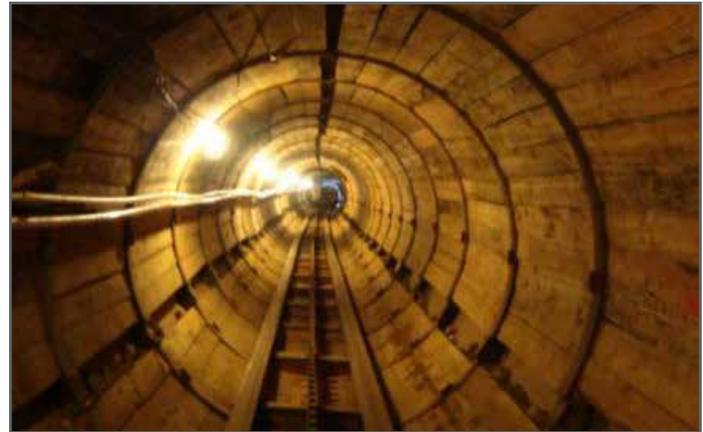
Figure 12. Completed upper rib and lagging tunnel prior to installation of the 54-inch storm drain pipe.

that was as much as 90-feet below PVDE (switchback roadway). The rib and lagging system requires a sophisticated TBM with hydraulic expanders at the tail end to allow the “W”-beam ribs to be fitted with a “Dutchman” expander that is bolted into place and effectively presses the rib and lagging (consisting of 3-inch thick x 5-inch wide x 5-feet long Douglas pine boards) into the surrounding soil. Once the entire rib and lagging tunnel was placed (see Figure 12), then the 54-inch diameter steel storm drain pipe could be installed, again with the annular space grouted. The preferred bottom-up tunneling method was utilized (see launch pit in Figure 13) facilitating the removal of spoils (on the return trip down). Each return trip back up included an otherwise empty muck cart loaded with another complete set of rib and lagging materials. The rib and lagging method was chosen because the length of tunnel and amount of friction anticipated in the irregular rocky soil would have prevented the use of a jacked sleeve installation, even with the addition of multiple mid-system jacks that create an “inch-worm” effect and a bentonite lubrication system.

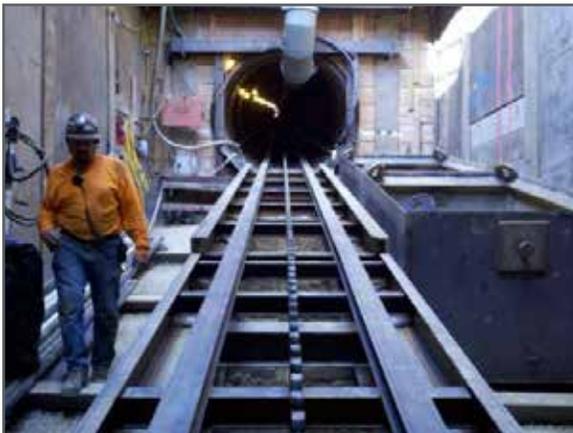
Figure 13. Upper tunnel launch pit just below PVDS/25th Street.

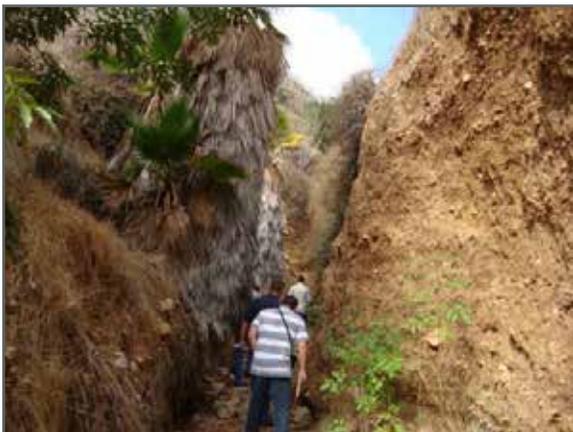
Figure 14. San Ramon Canyon bottom looking upstream with barren Tarapaca Landslide soil on the right.

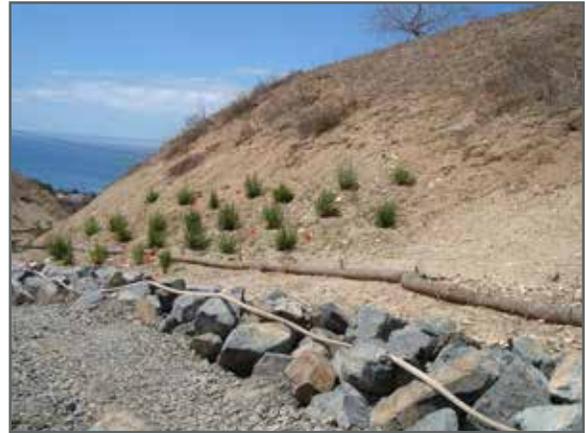
Figure 15. San Ramon Canyon adjacent to Tarapaca Landslide with rip rap rock bottom and landscaping in progress.

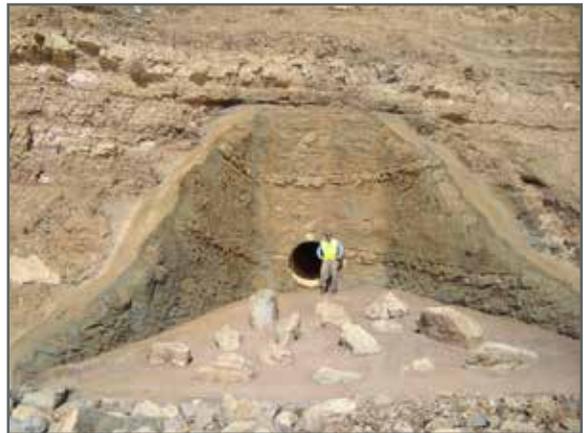
Figure 18. Outlet structure completed.

- Constructing an aesthetically pleasing outlet structure at the beach (see Figure 18), which is well camouflaged even a short distance down the beach.

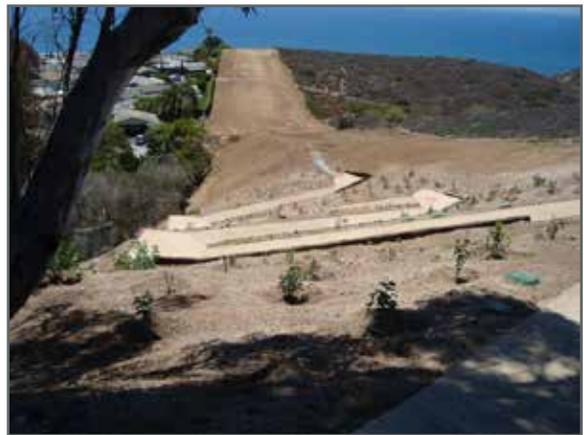
Figure 19. Completed maintenance access to the beach below 25th Street/PVDS.

- Creating an improved maintenance access road/trail to the beach below 25th Street in the sloped area where the long tunnel launch pit was situated (see Figure 19).

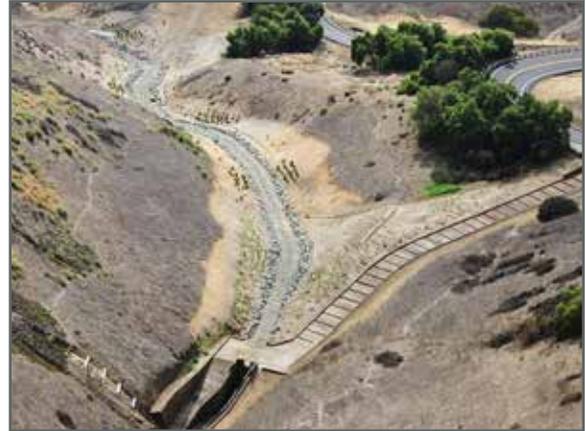
Figure 20. Completed maintenance access to the San Ramon Canyon inlet structure.

- Creating a significant maintenance access road from PVDE (switchbacks) to the inlet structure in San Ramon Canyon (see Figure 20).
- Savings realized by the net positive (credits to city) change orders on project allowed the City to add drainage and roadway paving improvements along the entire length of PVDE (switchbacks).
